**Compliance Inspection Report  
COS Samoa Packing Inc. NPDES Permit No. AS 0000027**

**November 6, 2006: Compliance Inspection of Facilities, Wastewater Effluent, Flow Measurement, Laboratory, and DMRs**

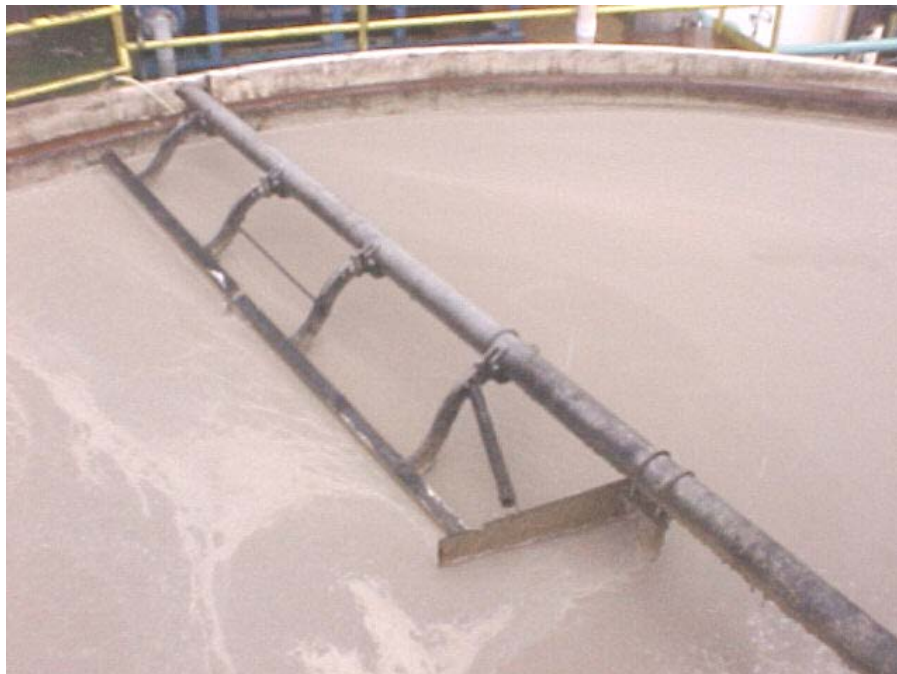
Photo 1: DAF

The wastewater is treated by the DAF. The DAF causes most of the suspended solids to float to the surface of the tank where it is skimmed off into the solids drop area and into the high strength sludge tank. The air pressure tank pressure gauges were difficult to read.

General Finding with Recommendation #1: The air pressure tank pressure gauges and flow meter was difficult to read. Recommend to repair the pressure gauges and flow meter box to allow for easier recording.
